# MEMORANDUM

## State Water Control Board

SUBJECT: Greenwood Chemical Company - Albemarle County

DATE: 29 January 1976

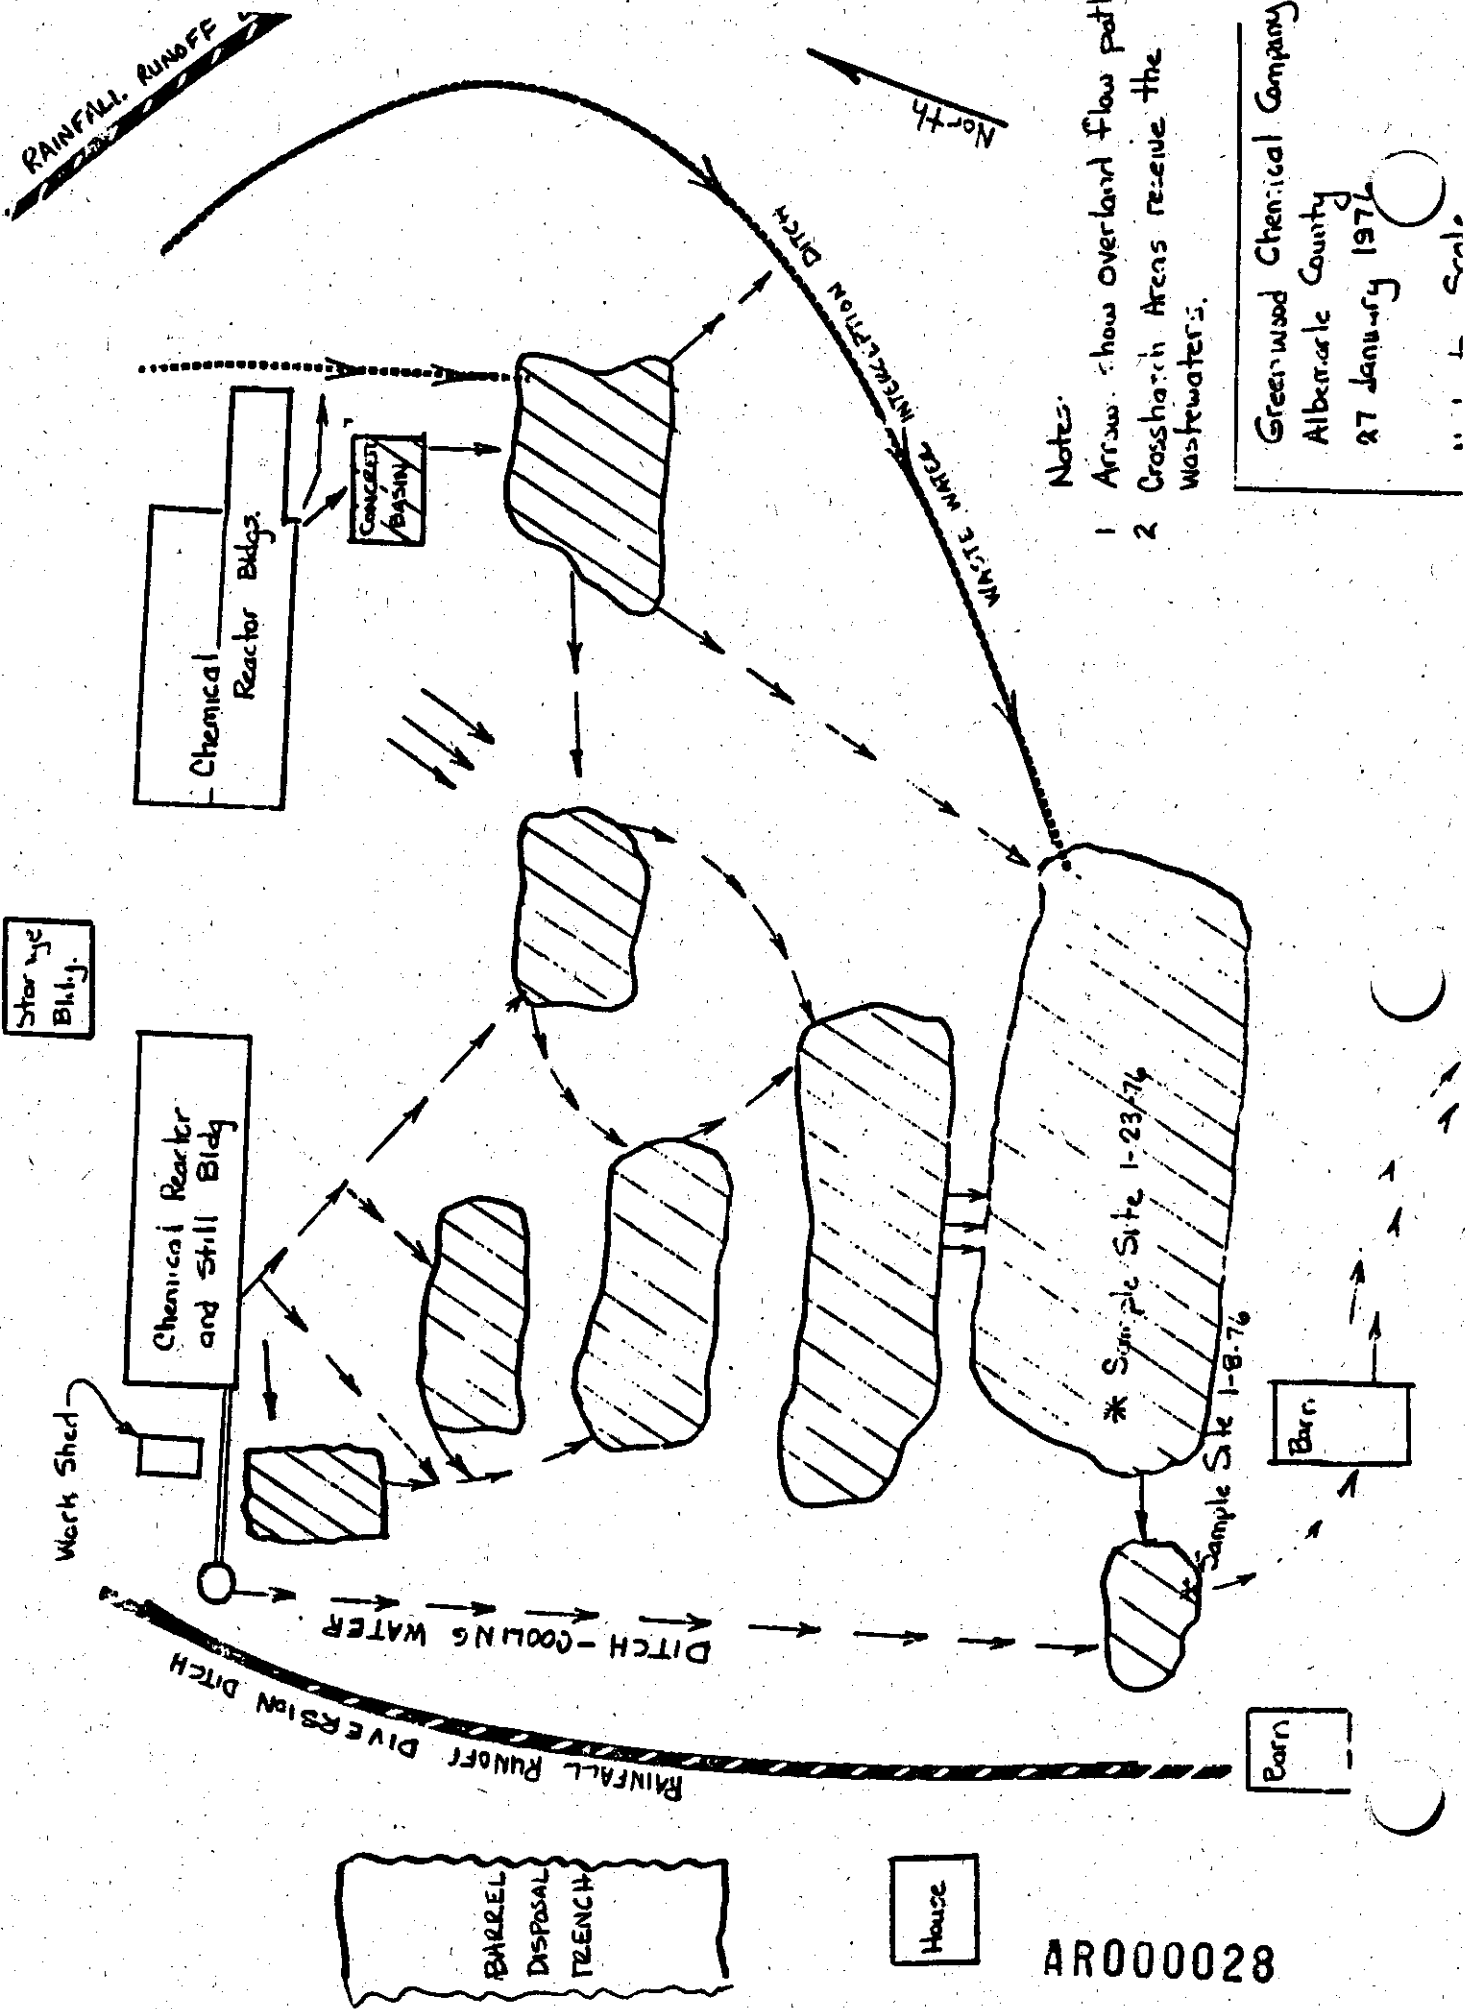
Greenwood Chemical Company  
Albemarle County  
27 January 1976  
L. Seal.

It was explained to us that single pass noncontact cooling water from condensers, was collected into a large PVC line on each side of the building, and directed out to a 55 gallon drum approximately 30 feet outdoors. Originally, the drum was used to supply a pump which recycled the cooling water back for reuse, however, the arrangement did not work because water use was higher than that being received at the drum at any given time, therefore the pump had been removed and the drum overflows to a runoff diversion ditch. The reduction of clean water flow into the waste holding ponds and the rainwater runoff diversion ditches on each side of the property were previously required as a condition for a Virginia no discharge certificate. Each side of the operating area in the building contained a gutter that received various stream trap discharges, cooling water from vessel jackets, and any other wastes lost and/or washed from the floor or equipment. These gutters discharged out of the corners of each building, a small pond receiving the waste separately from each building. It is impossible at this time to provide an accurate description of the waste flow arrangement and the receiving ponds. A

somewhat rough sketch is attached that represents a composite of the best determination of the flow and pond arrangements that the writer and Mr. Mizell could make following our last visit.

The grounds around the immediate working area and vicinity of the buildings were quite littered with numerous empty drums, (the ponds also contained numerous metal drums) and evidence of spillage of unknown materials. There was also evidence of flow across the ground from the buildings into the first receiving pond, although there were also pipes in the ground for that purpose. A clear flow channel or pattern was very difficult to distinguish. An old concrete walled pit was the first receiving point from the eastern most building, the concrete structure being broken, open, and allowing flow through into the next small pond. While it is presumed there is, or was intended to be, some flow arrangement organization from one pond to the next, Mr. Lyons was not able to explain the system to us, and I am sure it would take Mr. Shipman to do so. There was some evidence of overflow at one or two locations on one or more of the ponds. Flow from one pond to the next appeared to occur generally by ditch or eroded berms when one was immediately adjacent to the other. Due to the arrangement of the various ponds, and the topography of the area, all pond flows and/or ground runoff flow, inside of the runoff diversion ditches, should go into the somewhat larger pond at the lower end. Discharge from the area ultimately occurs by overflow at the south side of the final small pond (see sketch). There was no visible discharge at the time of our visit. The ponds were all frozen over to a depth of approximately 2 to 3 inches and there was ice on the ground outside the berm of the final pond at the discharge point. There is no defined channel from that overflow point to the intermittent tributary that is approximately 100 yards further down the slope at the property line.

On the front side of the plant's main building, is a storage building for what appeared to be raw materials in various types of drums. Behind this building, upgrade, (see sketch) there are 6 vertical storage tanks, estimated to 1500 - 2000 gallons each, 5 of which were labeled Toluene, and one Isopropyl Alcohol. An

VRO will pursue having the final pond berm immediately raised sufficiently in order to stop any discharge. Following that Mr. Shipman will be required to provide the necessary information in applying for a no discharge certificate, and in that process it would appear at this time that considerable upgrading of the lagoon facilities and possibly additional facilities will be necessary in order to assure a no discharge situation to our satisfaction, and with consideration of what the potential threat may be in relation to the content of the ponds.
